Description and analysis of the operation of on-board systems of Tu-154M aircraft No 101

Final Report – Appendix 2. Description and analysis of operation of on-board system of Tu-154M aircraft No 101

DESCRIPTION OF DAMAGE TO THE AIRCRAFT

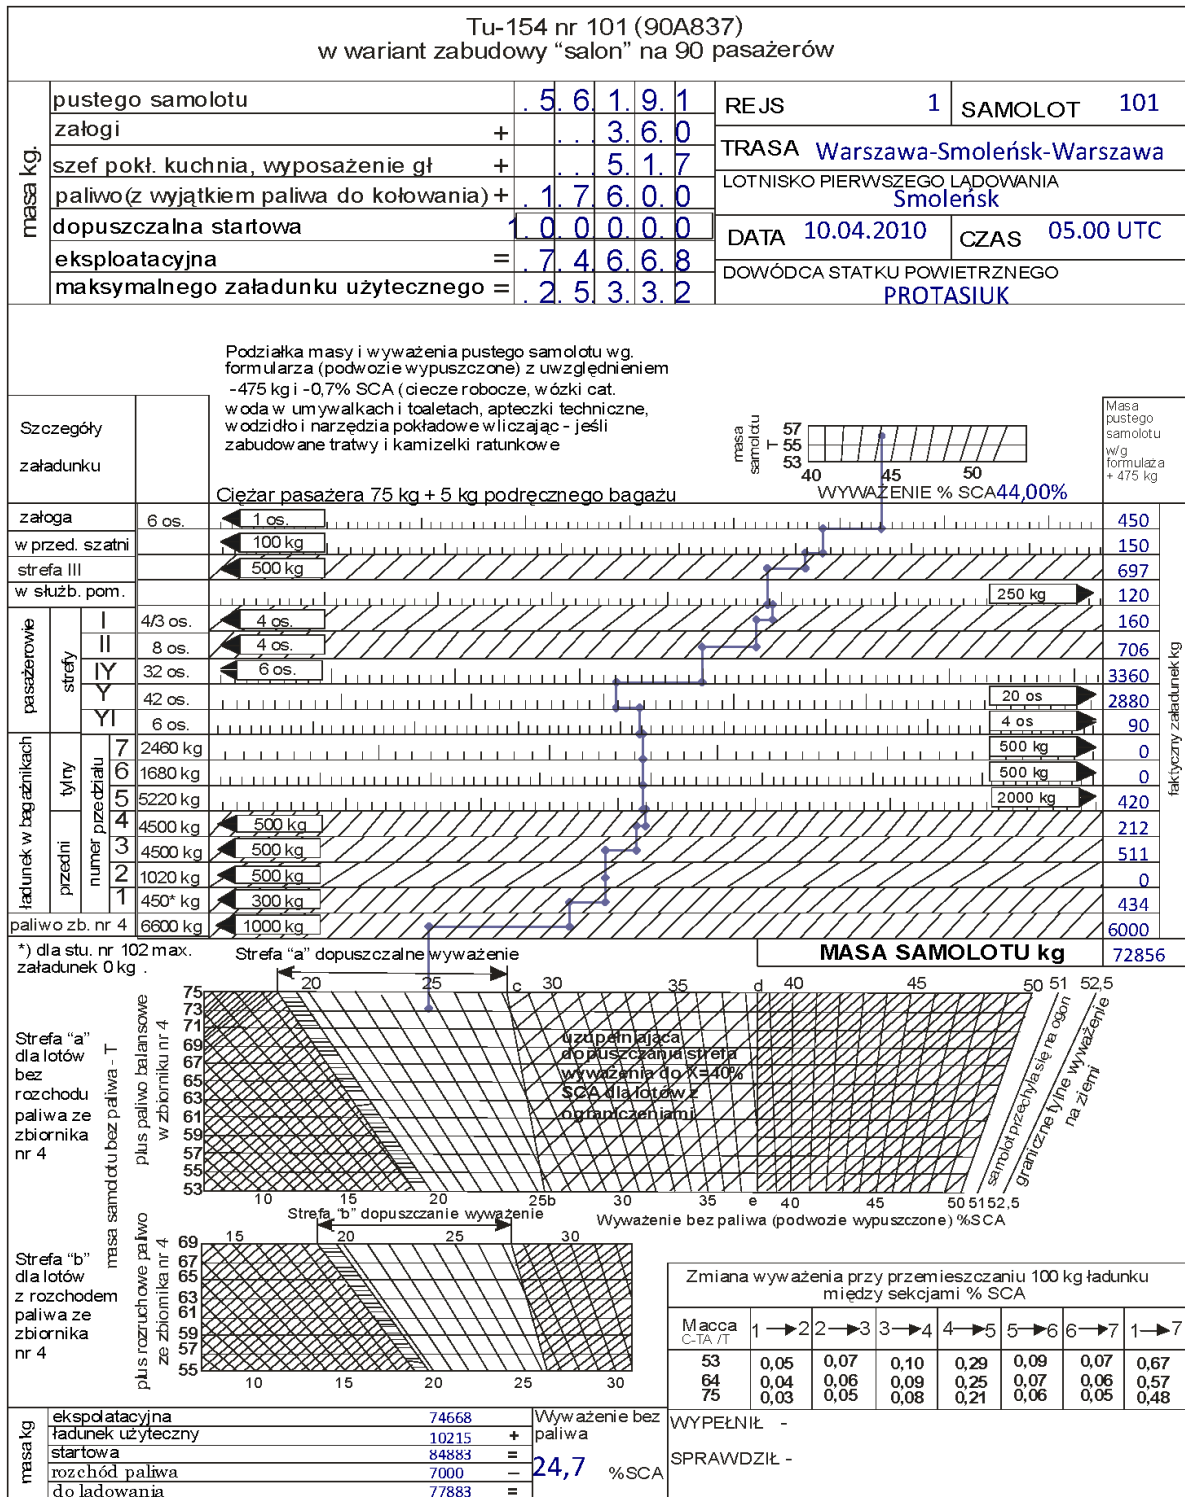
Upon departure from the WARSZAWA-OKĘCIE airport the aircraft's tanks contained 17,600 kg of fuel (according to the ATM QAR recorder), including 6,000 kg in tank 4 (ballast tank). The aircraft's weight calculated for the data as of April 10th, 2010, 0500 UTC, was **84,883 kg**. The center of gravity was at **27.7%** - middle position (Fig. 6).

Fig. 6. Balance chart for the aircraft Tu154M, tail number 101, prepared using data as for the flight of April 10th, 2010.

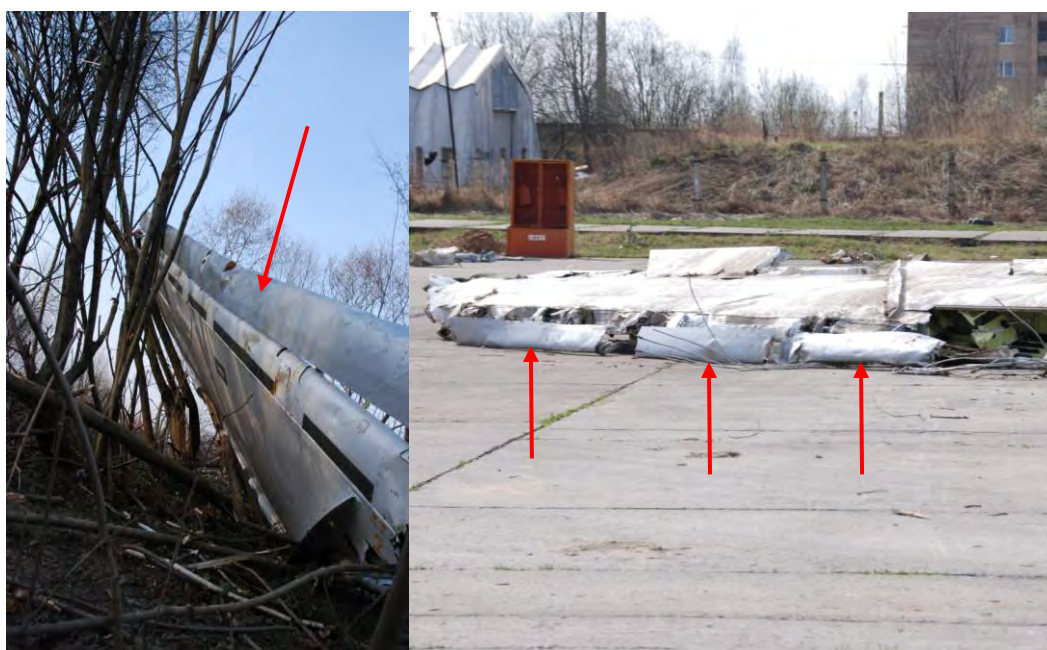
Fig. 7. The slats of the left and right wing of the aircraft in the extended position

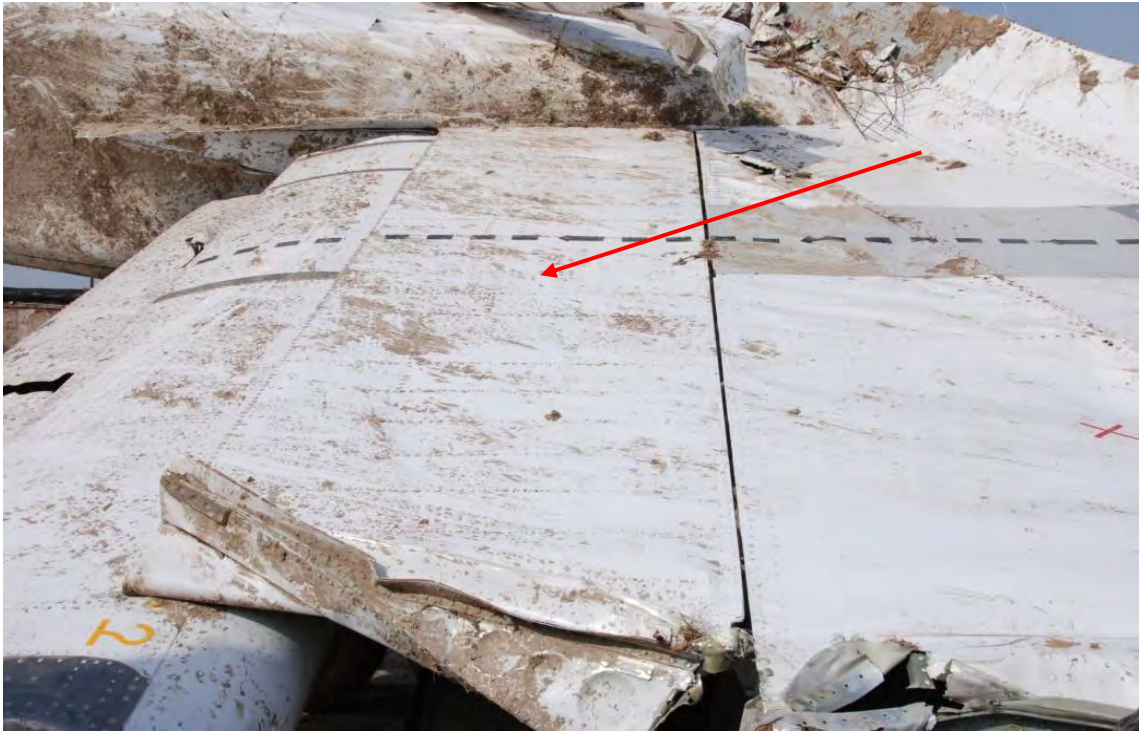
Fig. 10. The spoilers in the retracted position

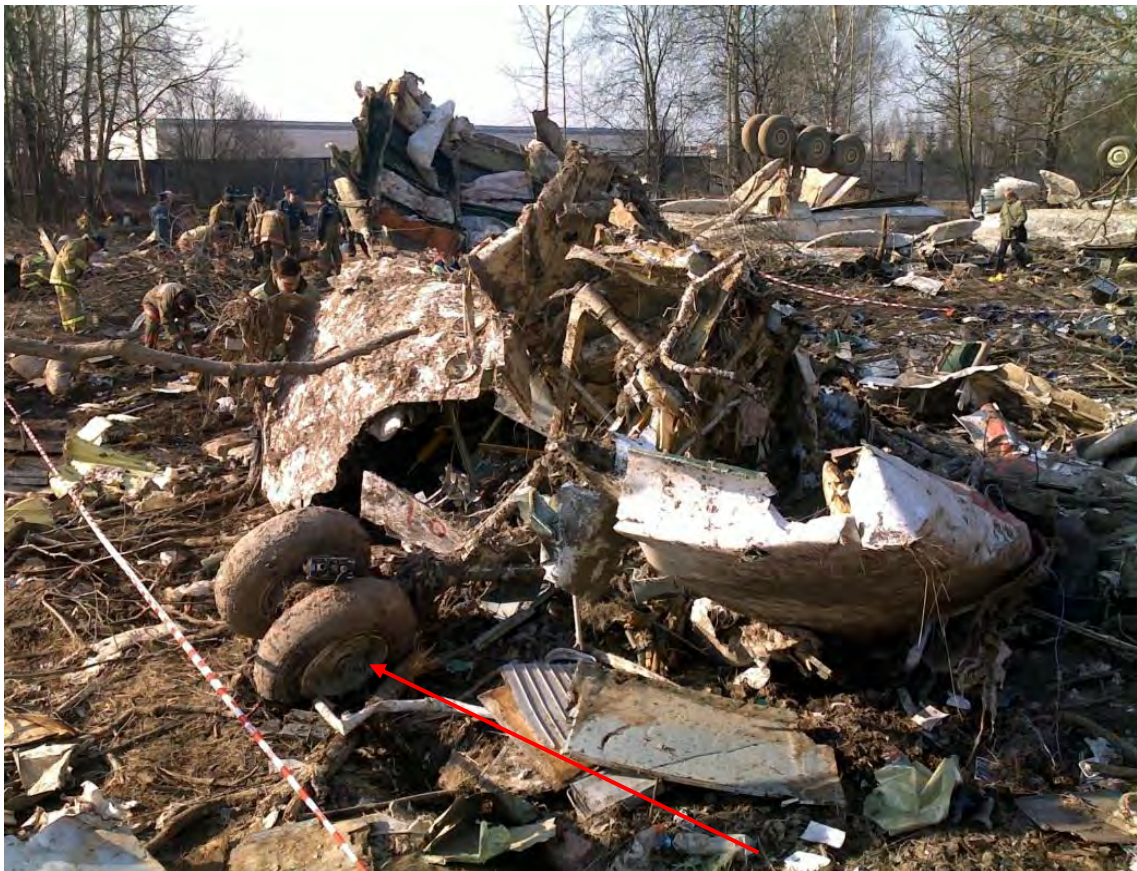
Fig. 11. The nose gear leg in the extended position

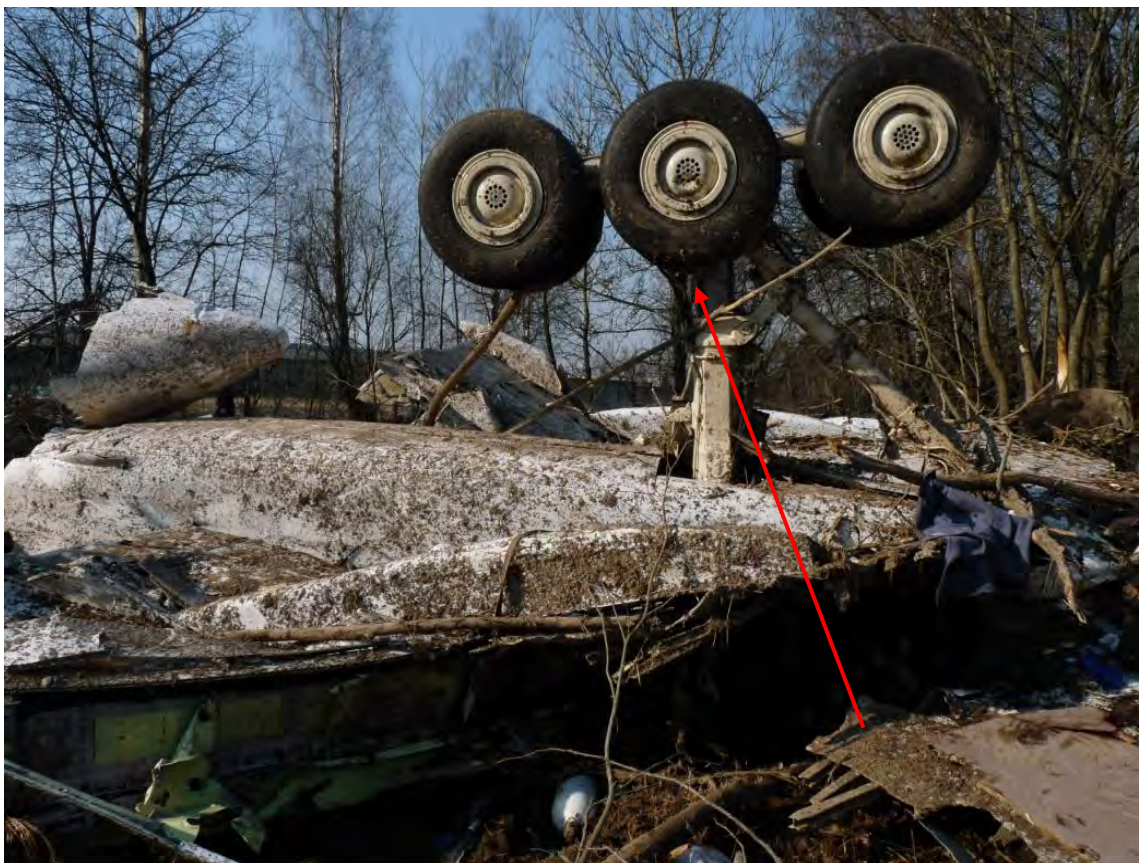
Fig. 13. The left main landing gear in the extended position

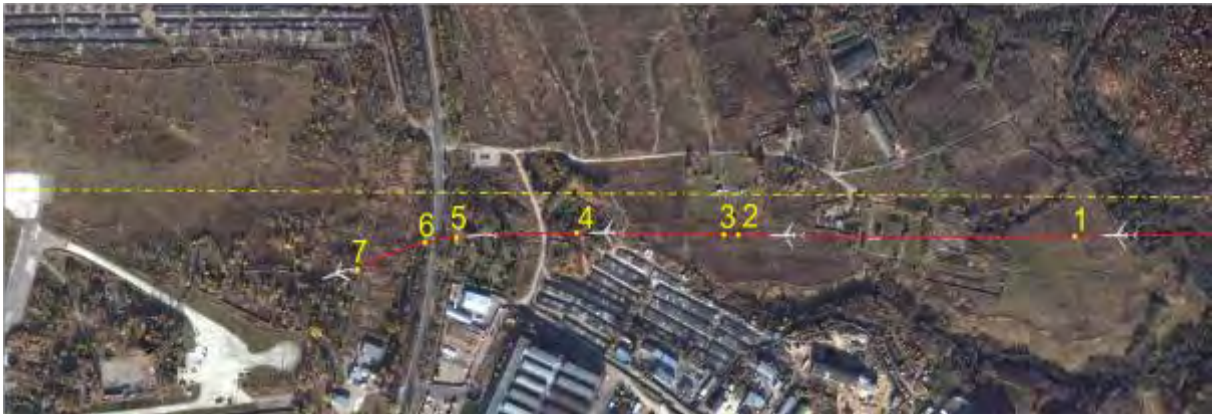
Fig. 1. Flight route and important points:

- 1 - radio altimeter activated (RA);
- 2 - birch tree in proximity of the inner NDB (INDB);
- 3 - inner NDB pole (INDB);
- 4 - birch tree – where the left wing tip separated;
- 5 - receding control wheel turn – end of the attempt to maintain level flight;
- 6 - end of QAR recording;
- 7 - first impact of the airplane with the ground.

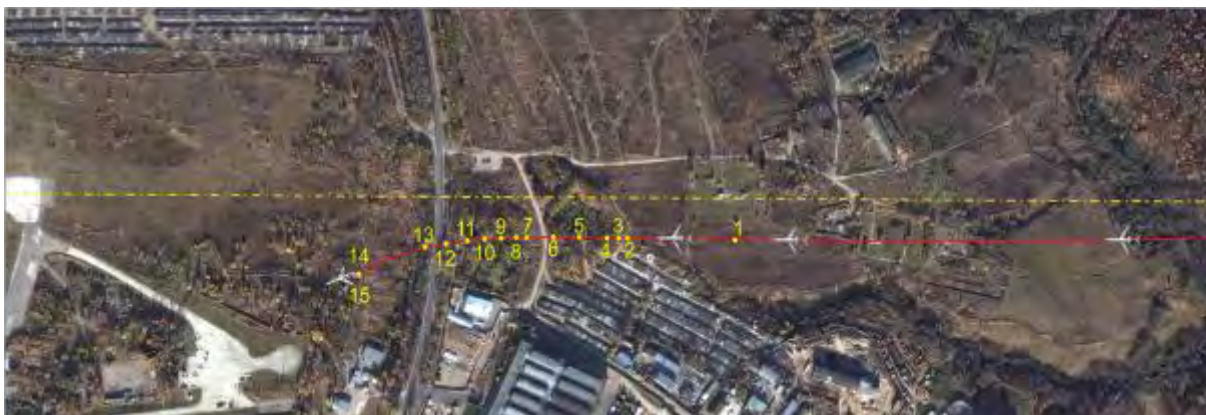
Fig. 2. Terrain obstacles and ground impact point:

- 1 - first birch tree trimmed;
- 2 - young birch cluster;
- 3 - young birch cluster;
- 4 - young birches and poplars;
- 5 - birch – separation of a part of the left wing;
- 6 - trees with limb diameters of up to 10 cm;
- 7 - power line;
- 8 - firs;
- 9 - birch;
- 10 - single fir tree;
- 11 - poplar;
- 12 - poplar;
- 13 - center of tree cluster west of the Minsk road;
- 14 - left wing mark (furrow) in the ground;
- 15 - left elevator and tail marks in the ground.

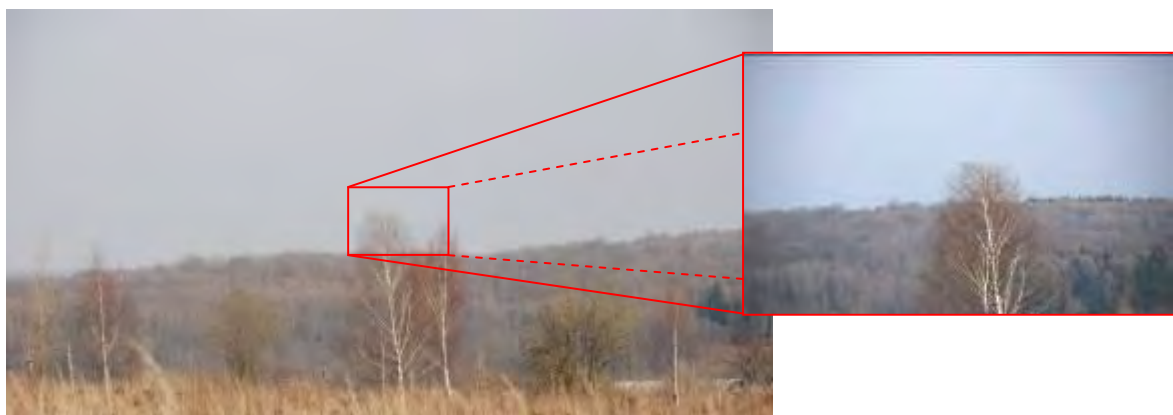
Fig. 3. Birch tree in the vicinity of inner NDB (item 2 – fig. 1 and item 1 - fig. 2) sheared by the right wing edge

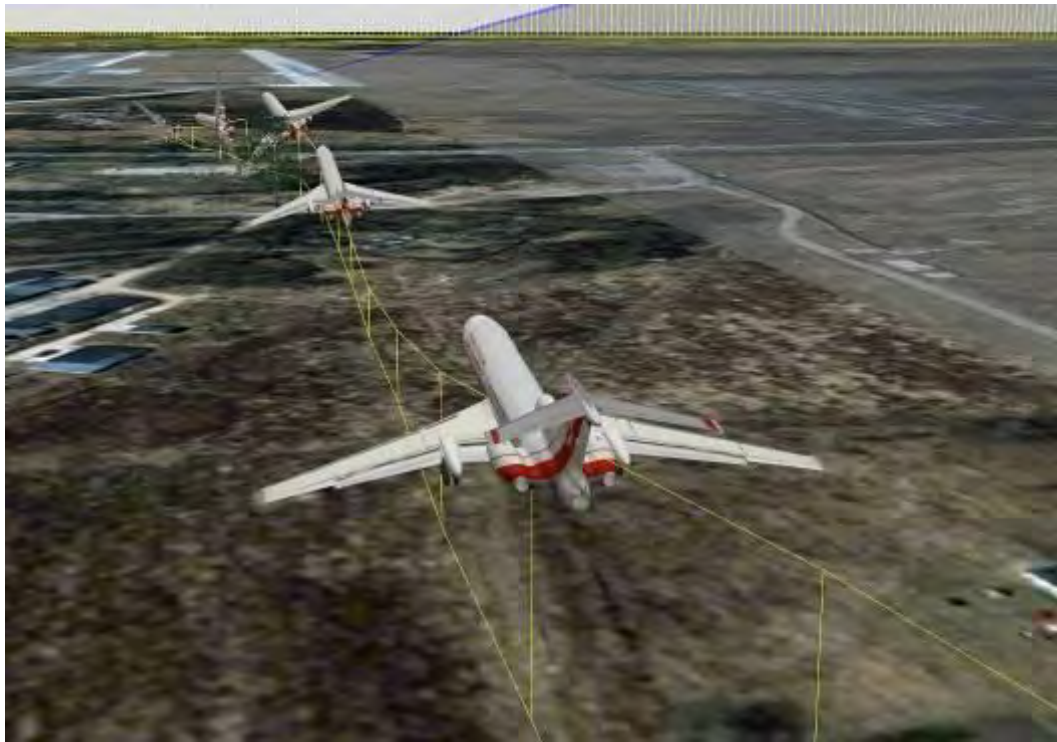
Fig. 13. Graphical presentation of the final flight phase and of the impact with the ground
(as seen from the direction of the approaching plane)

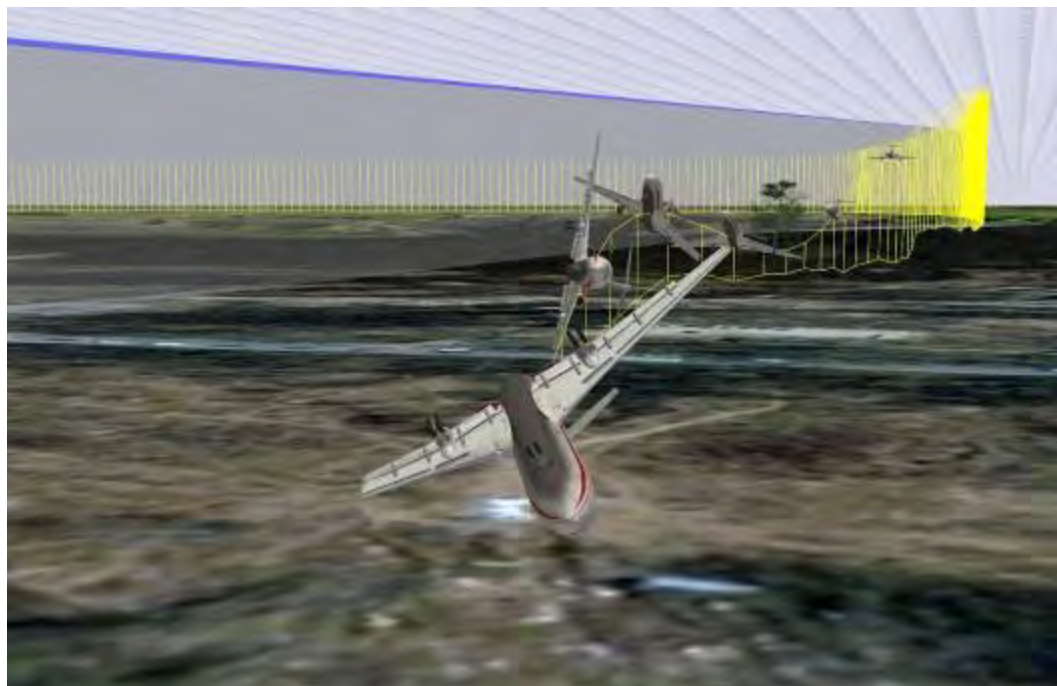
Fig. 14. Graphical presentation of the final flight phase and of the impact with the ground
(as seen from the direction of the crash site)

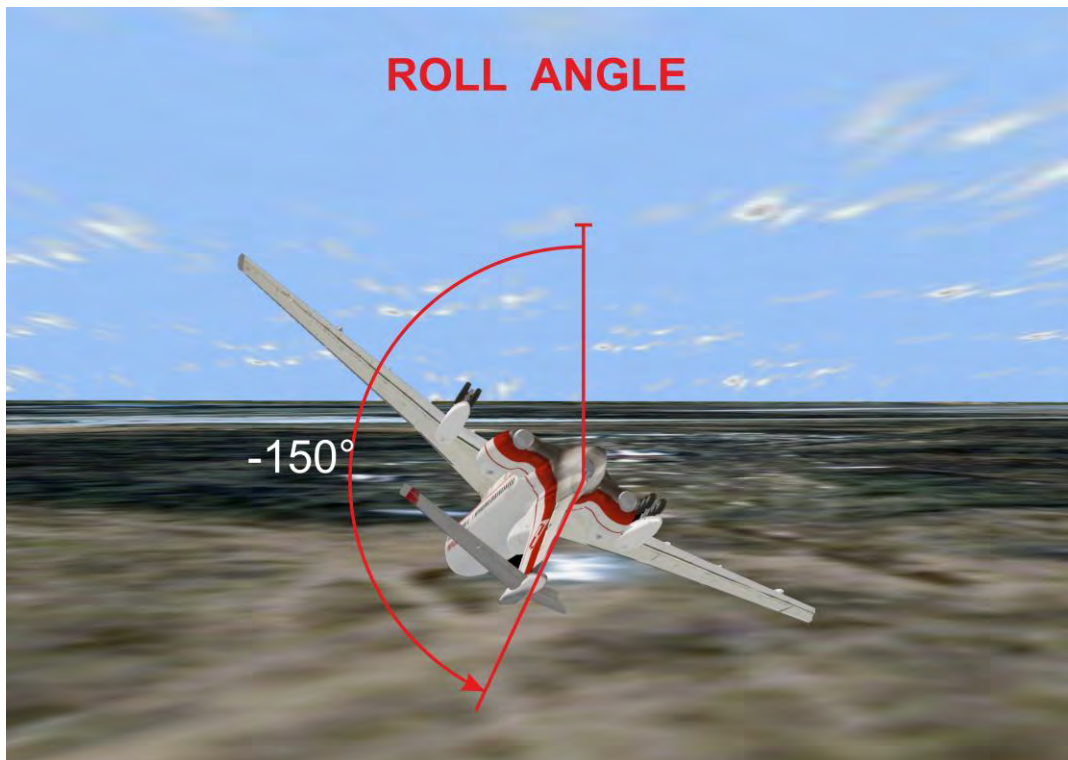
Eventually, the plane collided with the ground with the stump of the left wing first with a roll of approximately -150° (fig. 15), small negative pitch of about -6° (fig. 16), on a magnetic course of about 240° (from the moment of the left wing loss, the course deviated by approximately -20° – fig. 17).

Fig. 15. Roll angle at impact with the ground

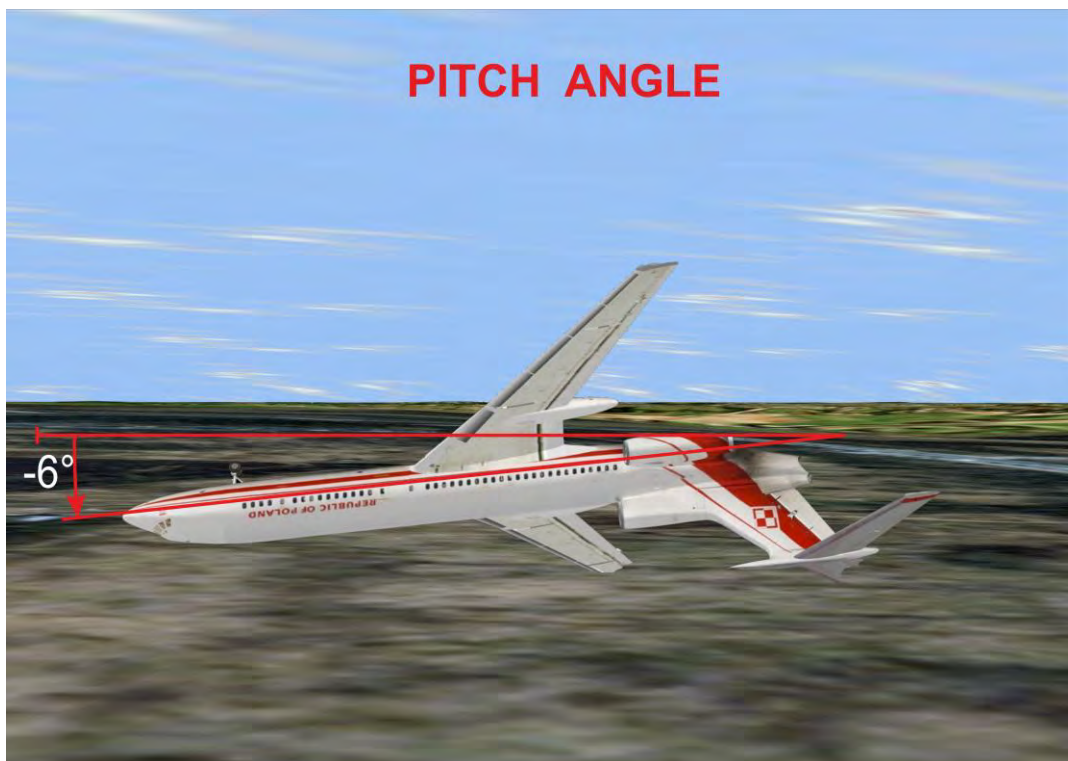
Fig. 16. Pitch angle at the impact with the ground

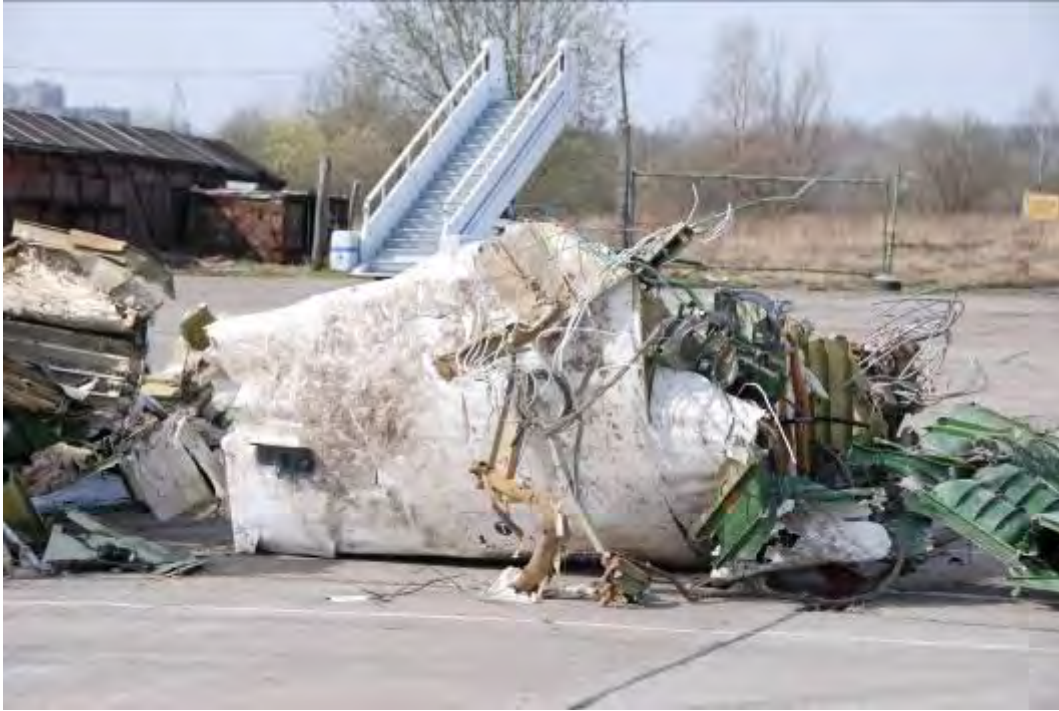
- b) A fragment of the lower section from frame 14 to frame 19 with the nose gear leg and some connecting elements thereof (fig. 8). The preserved fragment includes the lower fuselage section in the fixing area of the nose gear leg. The whole upper fuselage section from this area was torn into small pieces;

Fig. 8. A fuselage fragment at the fixing point of the nose gear strut

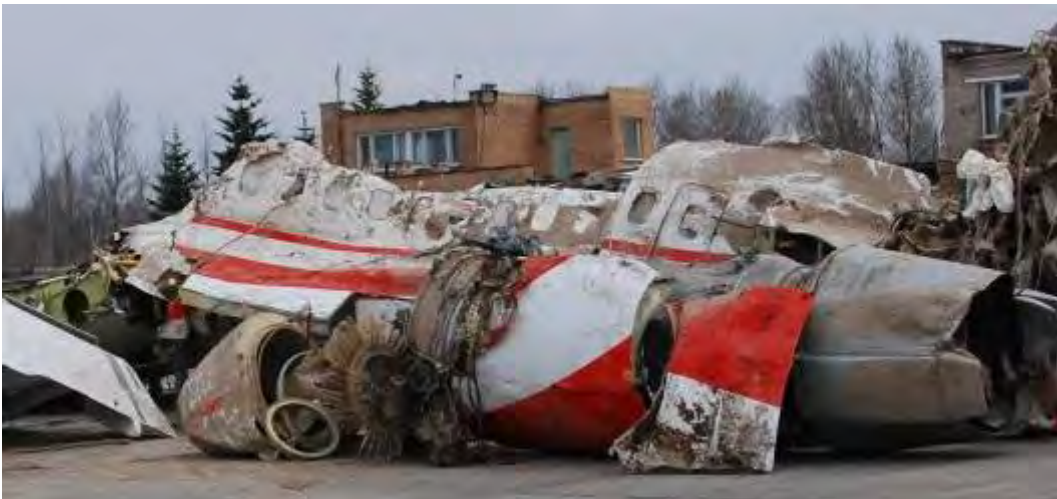
- e) The lower portion of the rear section with a crushed left aircraft's side from frame 52 to frame 62 (fig. 11). This fragment included the bent deck from the passenger compartment, lower fuselage skin panels, and fragments of the left aircraft's side skin panels. The right aircraft's side was torn away from the remaining part of this fuselage fragment at the level of the passenger compartment deck;

Fig. 11. The tail part of the fuselage - passenger compartment

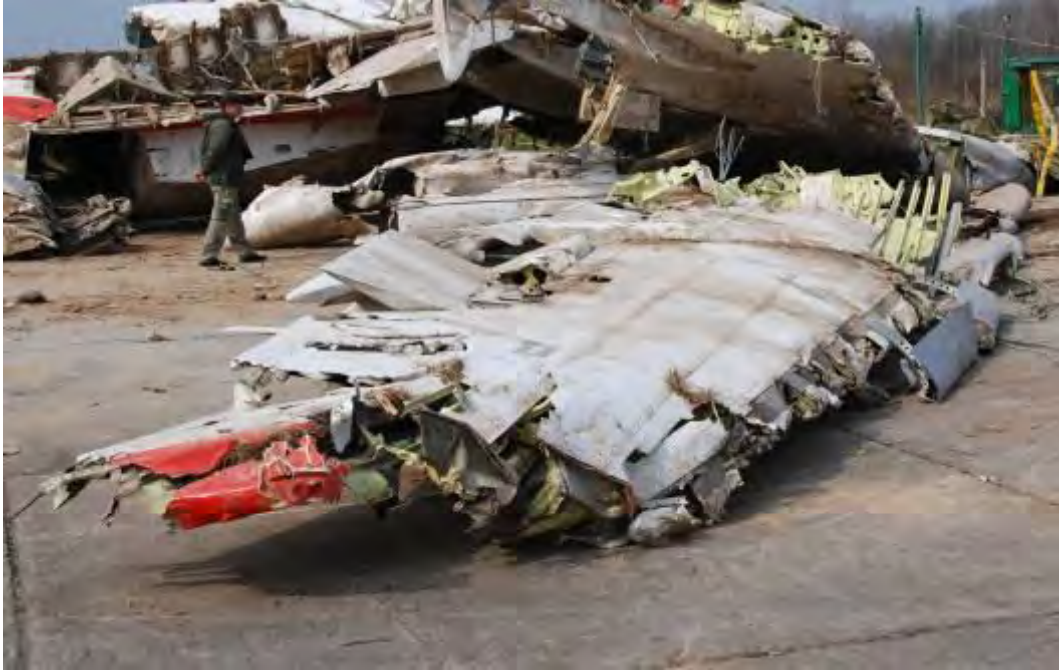
- a) The right outer part from rib 20 to rib 44 (fig. 33). Numerous oval dents can be seen on the leading edge and extended slats. Broken slat jack screws. Numerous tears in the skin panels.

Fig. 13. The right part of the wing

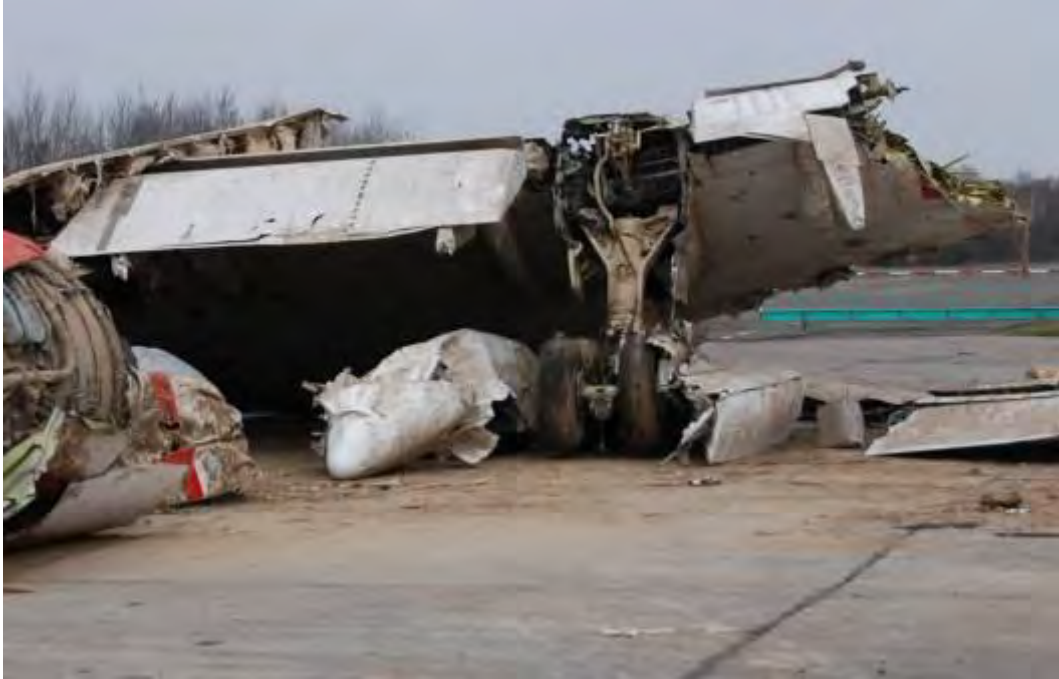
- b) The right part with the middle wing from frame 2 (left aerofoil) to frame 17 (right aerofoil) (Fig. 14 and 15) - the middle wing was torn asymmetrically. The slats were torn away from the wing structure. The dents and tears on skin sections at the wing leading edge extended to the front spar;

Fig. 15. The trailing edge of the right wing and the right main landing gear

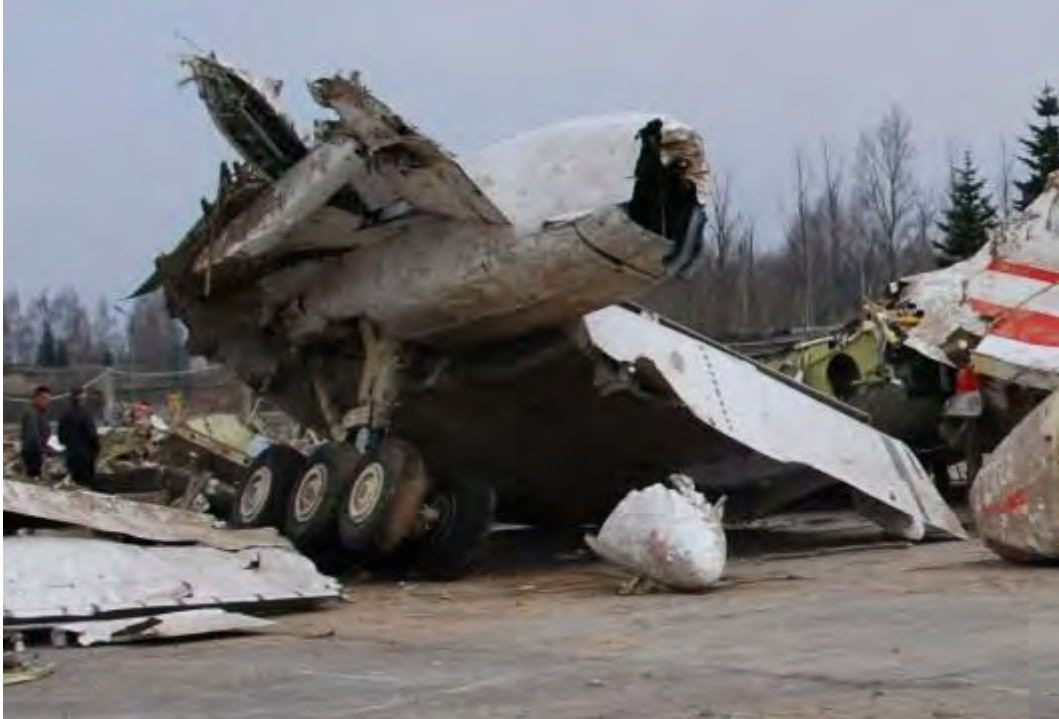
- c) The left wing from rib 4 in the middle wing to rib 16 in the detachable section (fig. 16 and 17). The skin panels are torn at the leading edge. Skin panels are bent out rearwards. Large sections of the upper wing skin panels are torn off. The damage to the left wing aerofoil was significantly heavier than that found on the right one;

Fig. 17. The trailing edge of the left wing and the left main landing gear

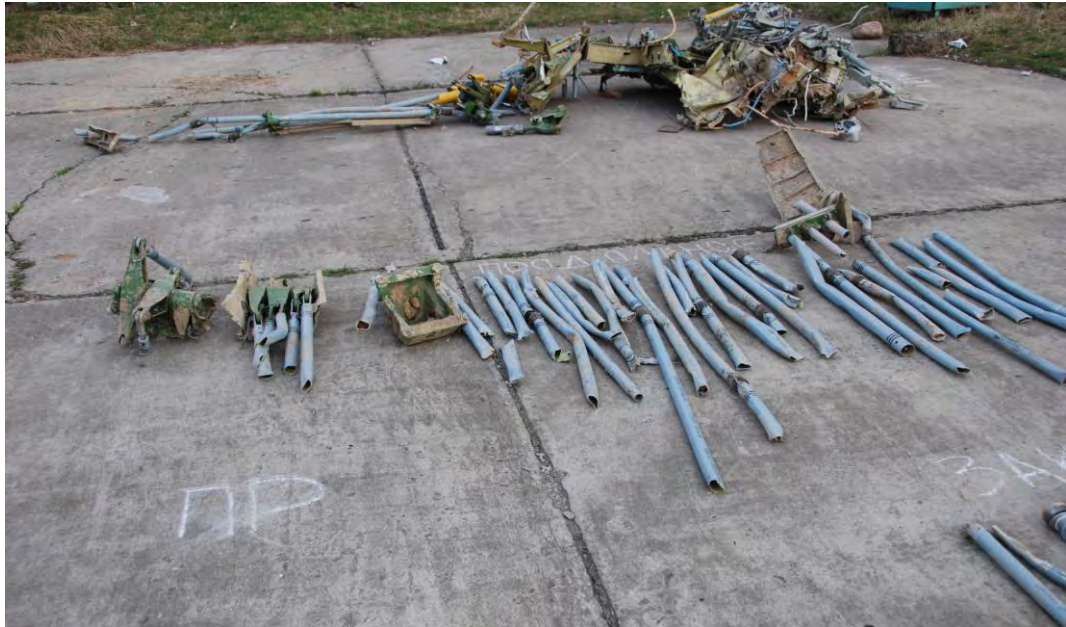
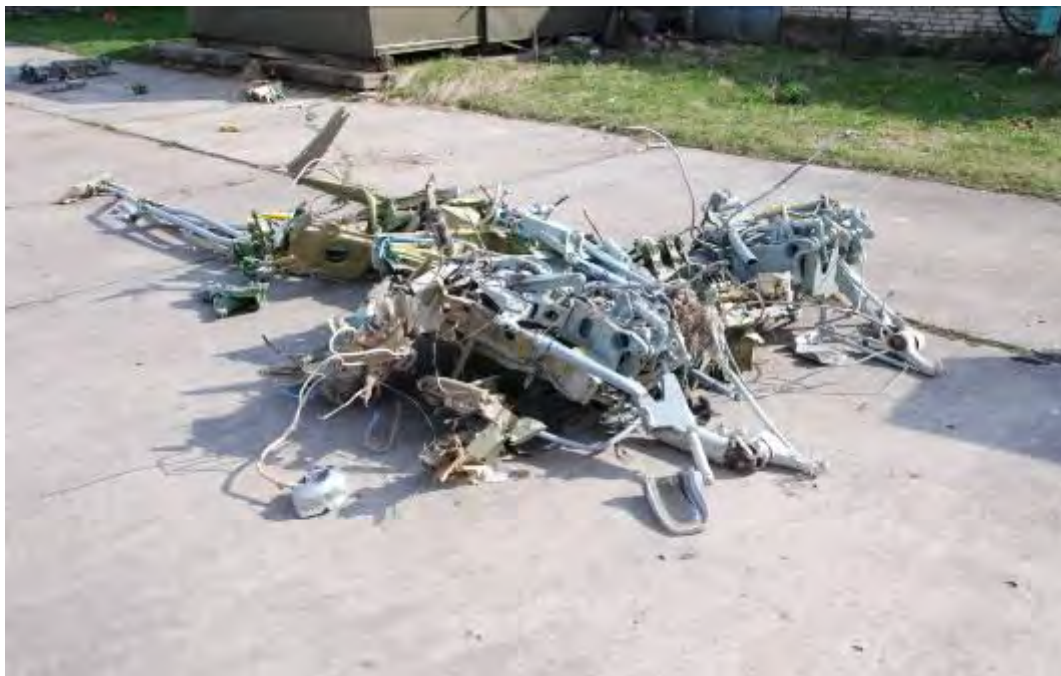
Fragments of control wheels and distorted pedals together with the gear located under the cockpit deck were preserved. The elevator, aileron and rudder control rods have numerous tears both at the riveting joints with the tip elements, and on the straight sections (fig. 25 and 26). Control cables torn apart.

Fig. 25. The control rods of the aircraft

Fig. 26. The remains of the aircraft's controls - the elements installed in the cockpit and under the cockpit deck.

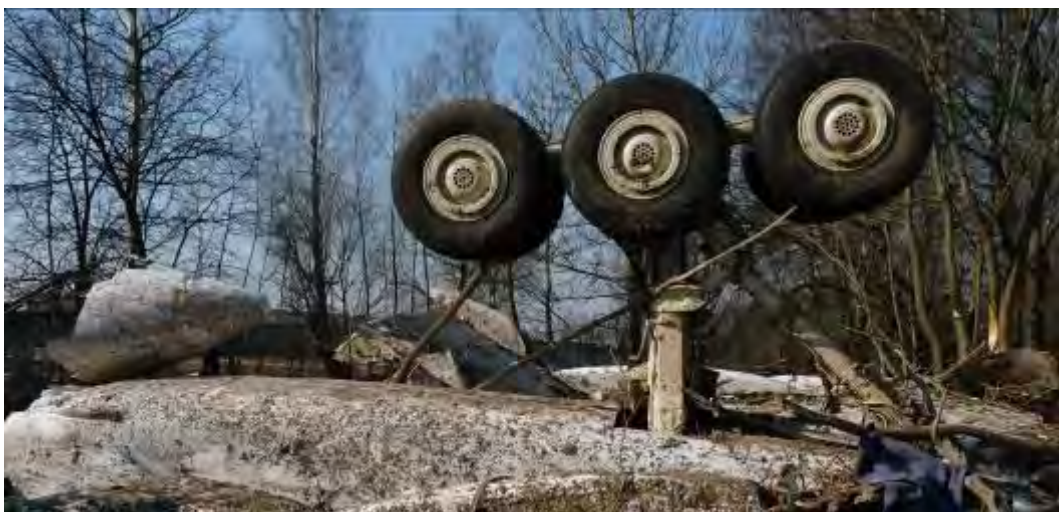
Fig. 27 The nose landing gear

The nose gear leg with impact traces is still attached to a fragment of the nose part of the fuselage. The angle brace of the undercarriage strut is slightly bent. The main landing gear legs bear slight impact traces left by tree branches, especially on the strut fairing. The landing gear is in the extended position and locked. No visible traces of damage have been found on the nose and main landing gear wheels (fig. 27-29).

Fig. 28 The left main landing gear

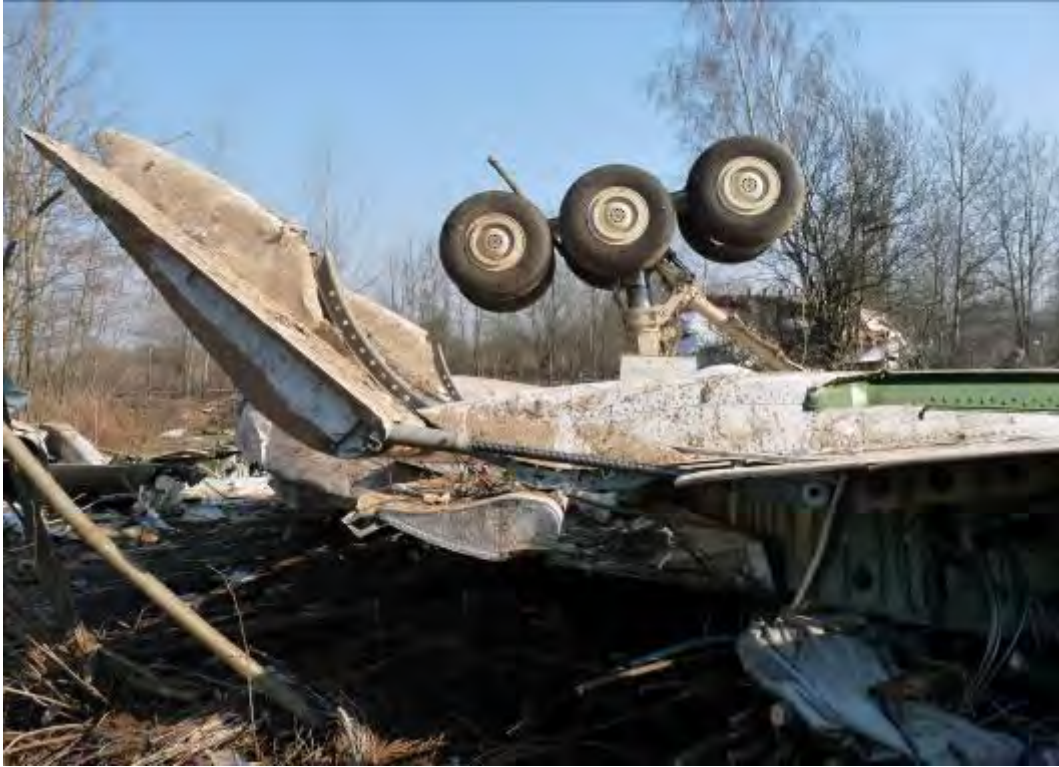
Fig. 29 The right main landing gear

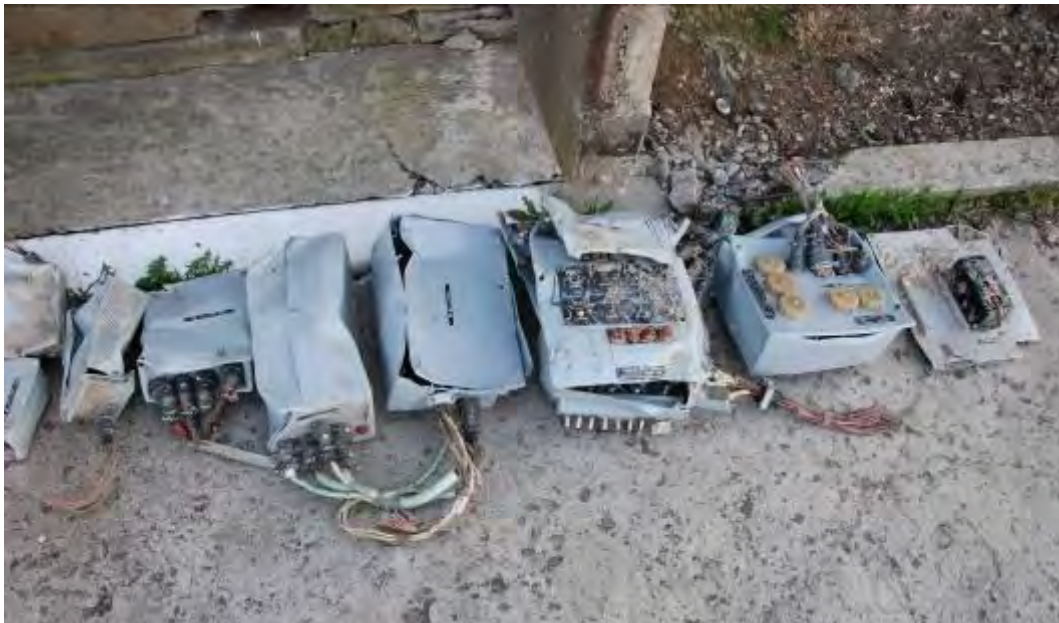
Wiring harnesses are torn apart. The control boxes are deformed. Switch levers are bent and torn off (fig. 30). The housings of the onboard batteries are deformed. Some cells became unsealed.

Fig. 30. The control boxes of the electrical system

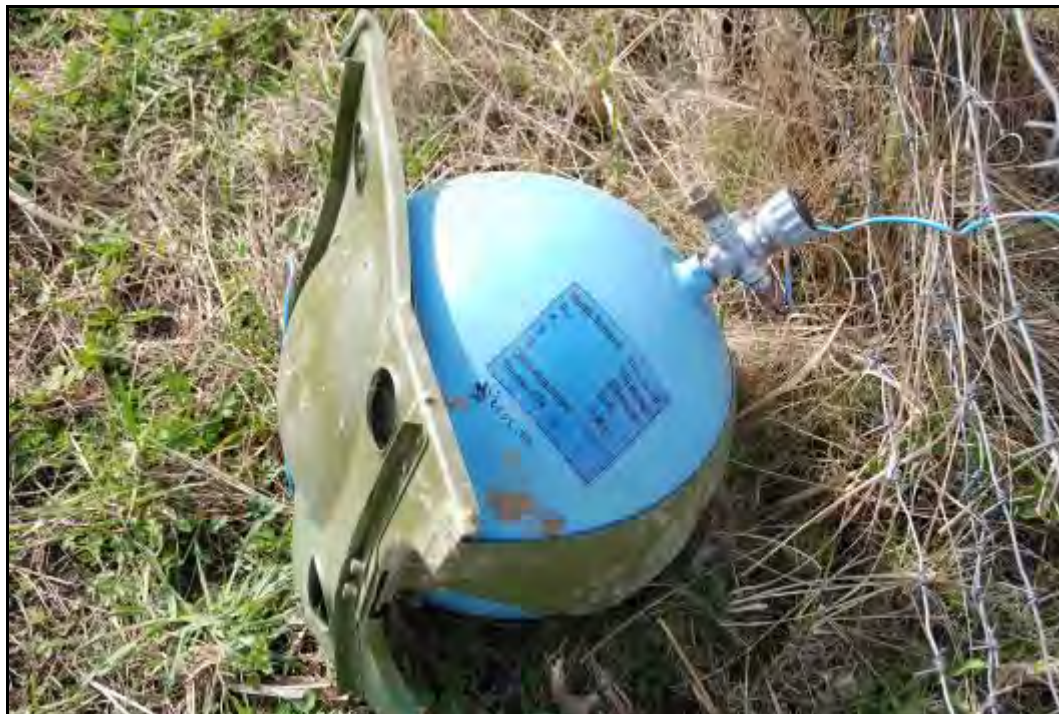
At the scene of accident only УБШ-25/150М bottle, no. 1100477, was found; the bottle was not disrupted but torn away (together with a part of the mount to which it was attached) when the aircraft's structure was being damaged.

Fig. 32. УБШ-25/150М bottle with a part of its mount and oxygen lines

The bottle was fitted with a cylinder top with a manometer and inlet and outlet connections. There is a longer section of the oxygen line attached to the inlet connection of the bottle; the outlet oxygen line was torn away at the very connection. The bottle bore neither traces of fire, nor any deformations caused by other elements of the aircraft.

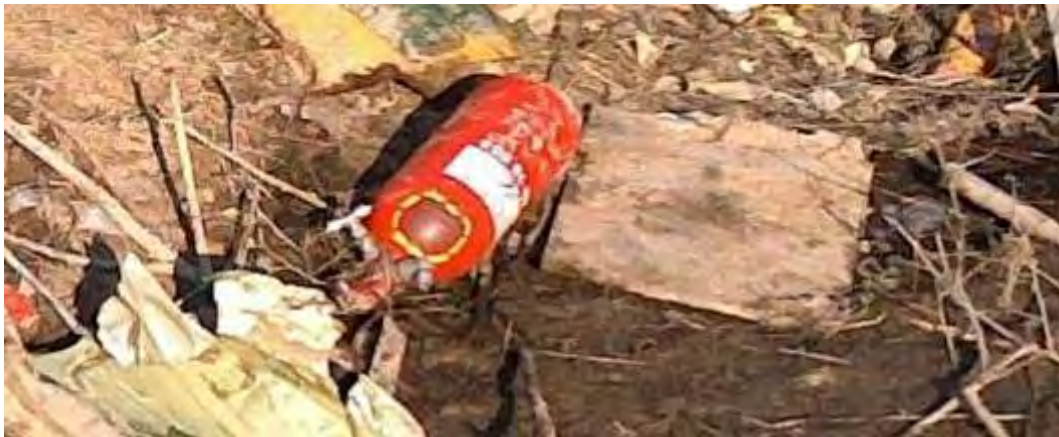
At the scene of accident one bottle OCY-5II-01 no. 08056 was found; the bottle was not disrupted but torn away when the aircraft's structure was being damaged (fig. 33).

Fig. 33. OCY-5II-01 bottle

The bottle was fitted with a cylinder top with inlet and outlet connections. The bottle bore neither traces of fire, nor any deformations caused by other elements of the aircraft.

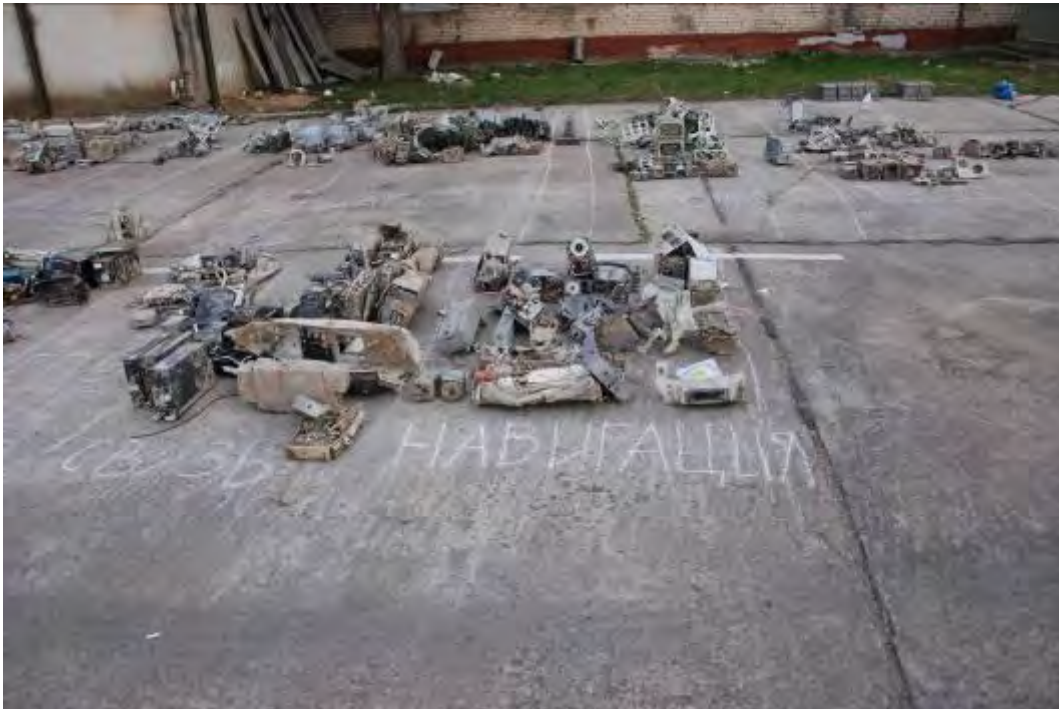
The equipment installed in the bays under the deck survived the crash in a better condition. However, most of the unit's casings were heavily deformed (Fig. 34). Some electronic blocks' casings were torn apart while modules with electronic units were broken and destroyed. In spite of the substantial damage, data was read out from the TAWS memory and UNS-1D system that was installed on the Co-pilot's side (one of the two installed on the aircraft).

Fig. 34. Navigational and communication equipment units

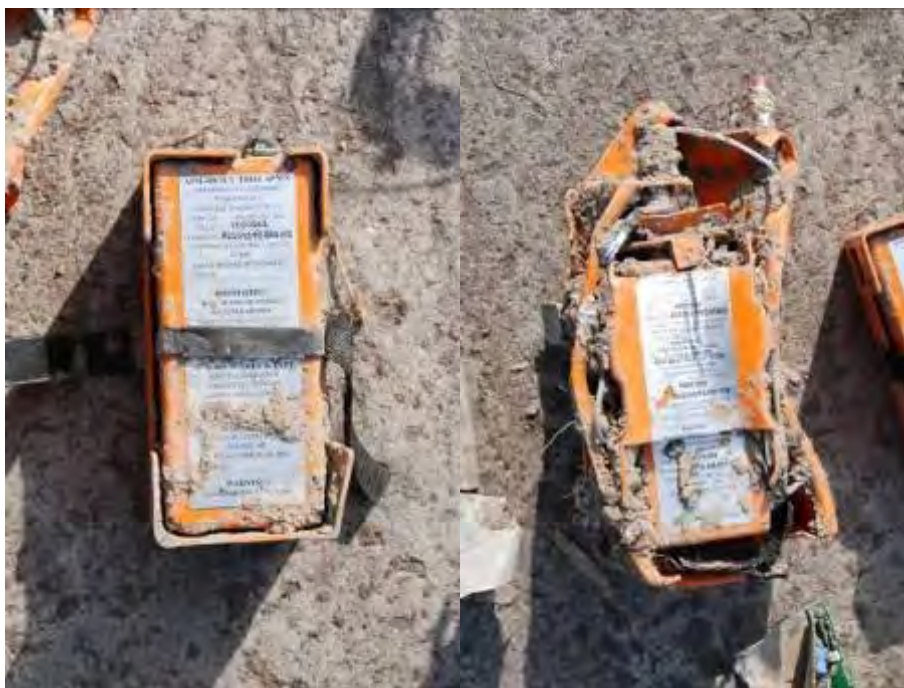
Installed during the last overhaul, the ARM-406AC1 (no. 7523242494) and ARM-406 (no. 7524241208) radios and their antenna systems became damaged in the crash to the extent of inoperability.

Fig. 36. Emergency radio stations ARM-406AC1 (left) and ARM-406P (right)

The ARM-406P radio station (automatically enabled with a G-load switch): the antenna and power cables torn away, the radio station casing crushed. The ARM-406AC1 radio station: slight damage to the casing (in order to use the radio station, the crew has to wire up the antenna and switch on the device).

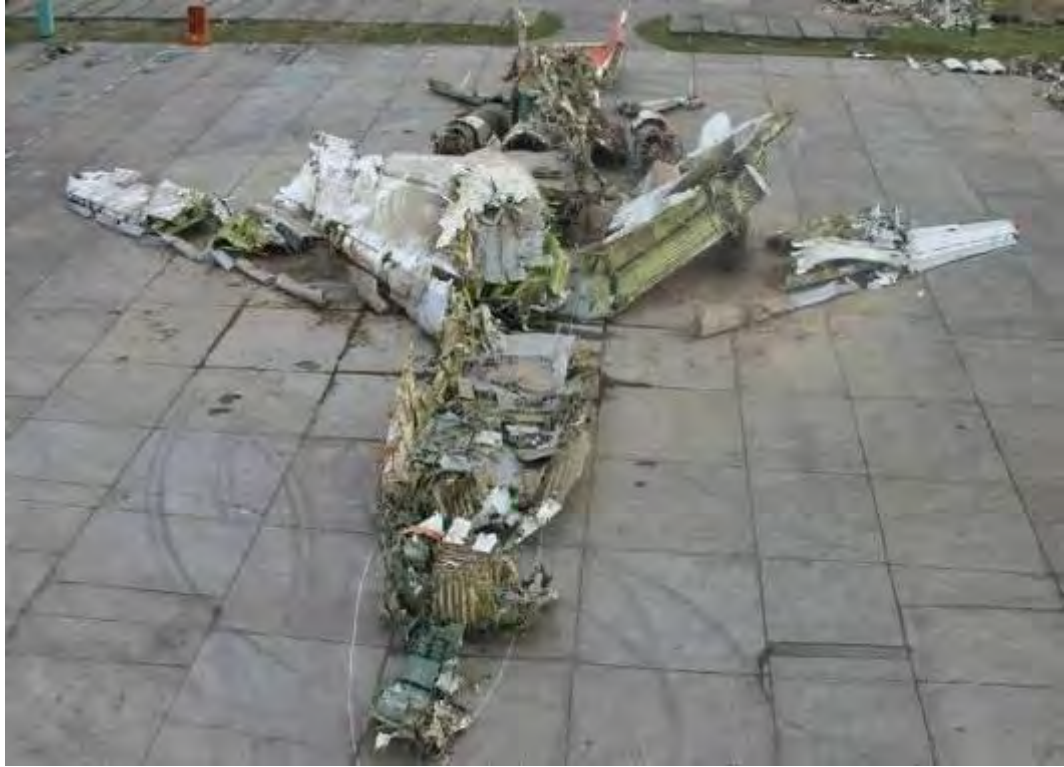
Fig. 37. Parts of the aircraft as arranged on the ground
